Fiberglass Deck Repair—Part II

Creating a non-skid deck

By Bruce Niederer

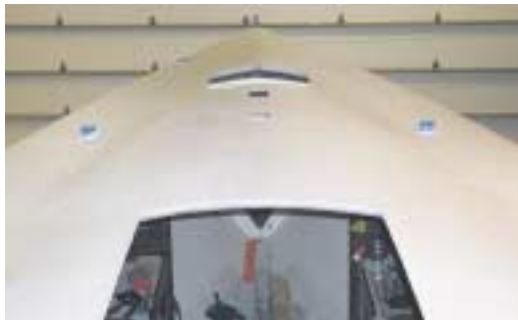
In Part I, we left the repaired deck with two coats of primer, ready for finish paint and non-skid.

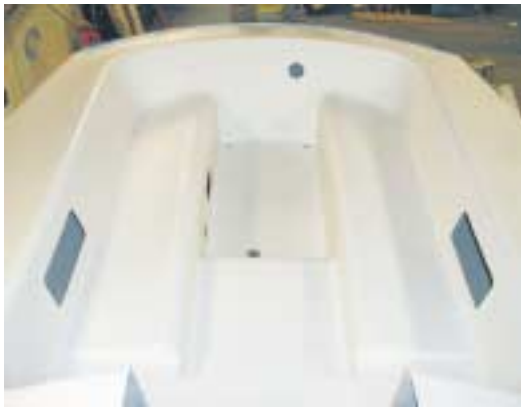
The cockpit after priming with US Paint™ epoxy primer white base, applied with an 800 foam roller.

We chose US Paint™ Epoxy Primer White Base as the primer. This is a 1:1 system, which is easily mixed and applied with a WEST SYSTEM® 800 Foam Roller Cover and foam brushes, when used with the proper converter. With two people working side by side from bow to stern, tipping as we went, we applied the first coat of primer in about 45 minutes. This coat was allowed to dry 24 hours. The next day, we prepared the entire primed surface using an abrasive pad on most areas and 220-grit sandpaper on any area that needed a bit more attention. We applied a second coat in the same way as the first and allowed it to cure until the next weekend.

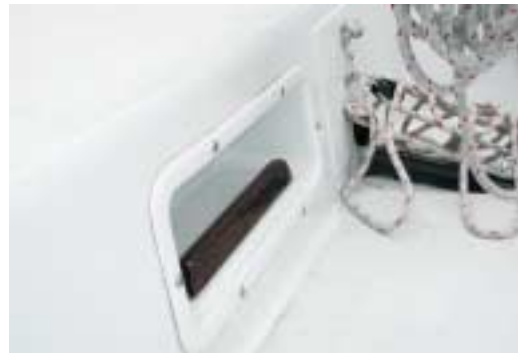
Above—The chainplates, isolated from the core material with an annulus of thickened epoxy, before and after fairing, barrier coating and priming.

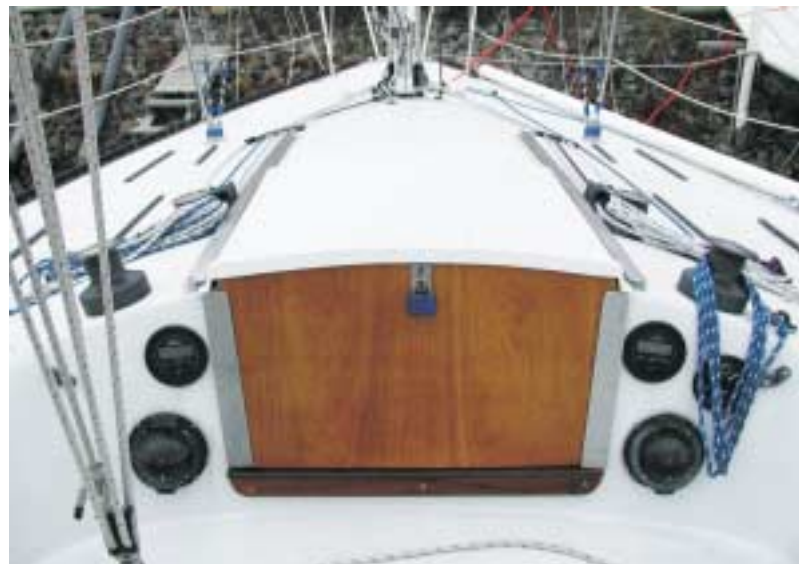
Left and below—The finished project. After two coats of Awlgrip™ Matterhorn white urethane, we masked off the areas we wanted to remain smooth. We mixed and applied a third coat thickened with 406 Filler to create the non-skid texture.

The first job when we returned the next weekend was to tape off all the areas we wanted to remain smooth. Then we sanded all the surfaces that were to be non-skid with 220-grit paper or an abrasive pad and cleaned in the usual manner. To create the non-skid, we prepared the same paint mixture as for the smooth coats, but without the reducer. Then we added 406 Colloidal Silica until the paint was the thickness of drywall mud. This mixture was spread out on the deck with an 809 Notched Spreader using the middle-sized, " notches. This was then rolled through lightly, using a medium nap roller cover, to create a texture like stucco. Two of us, working side by side like before, were able to apply the
